DOMINGUEZ CHANNEL BATHYMETRIC SURVEY AND SITE INVESTIGATION

June 16th, 2018

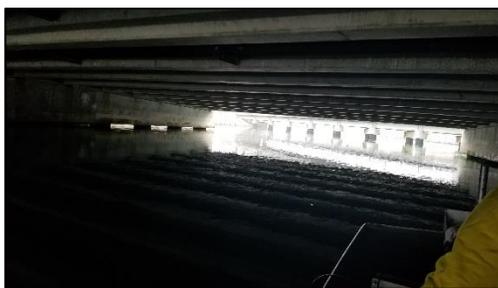
Figure 2. Transiting under the POLA Railroad Bridge

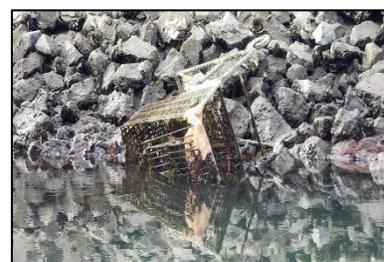
Figure 3. Shopping Cart in the Dominguez Channel
